Title: ISB 6.7 Frequent Regeneration

Applies To: IC Bus, MV, DuraStar with ISB or B6.7

This document will guide the user through resolving frequent regen issues on vehicles equipped with an ISB 6.7.

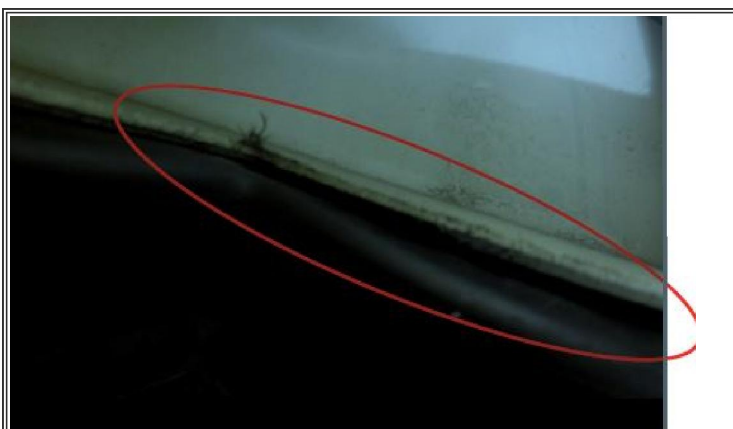
1. Airbox boot seal to the hood compromised allowing hot air from the engine bay to enter the intake. Middle section of the seal may appear bent or folded in. The seal position may appear off-centered from the hood.

Step	Action	Decision
3	<p>DIAGNOSTIC:</p> <p>With the hood in the fully latched position, inspect the accordion boot seal to hood.</p> <p>See Figure 1 and 2</p> <p>Is a gap present between the seal and hood?</p>	<p>Yes. Replace the cover assembly.</p>
		<p>No. Return to Fault Code Diagnostics</p>

Figure 1: Gap between Boot seal and Hood

Step	Action	Decision
2	DIAGNOSTIC: Use INSITE™ electronic service tool to monitor the compressor intake air temperature and ambient air temperature sensor values.	Yes. Replace the cover assembly and retest. See Figure 1 and 2 below

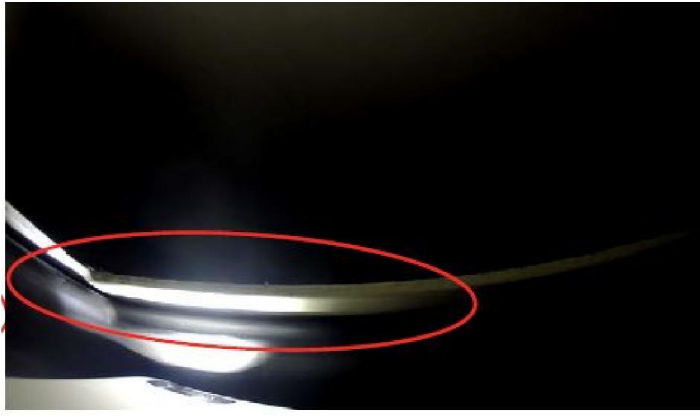
Figure 2: Hood misaligned with respect to Boot seal

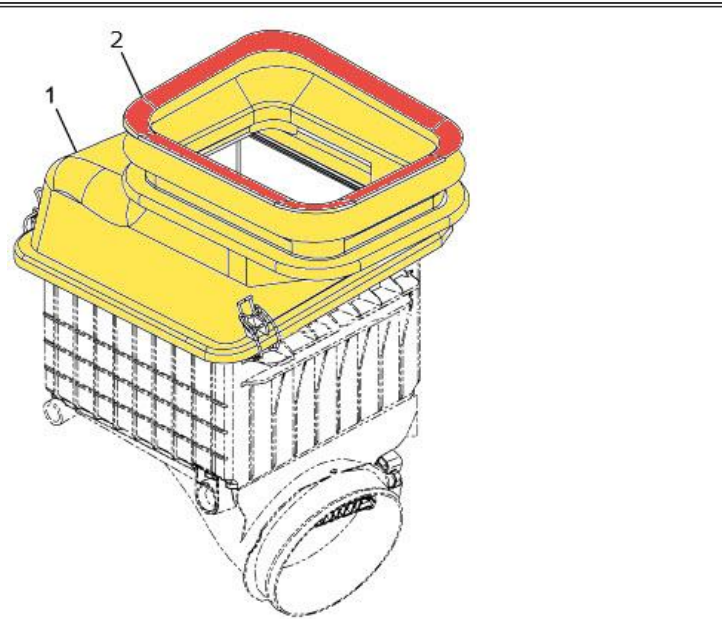
Figure 3: Air Cleaner

Item 1: Air Cleaner Box Cover PN 2602202C91 (highlighted in yellow)

Item 2: Seal lip inspection area (highlighted in red).

Kit Description	Part Number	Quantity Required	Notes
COVER ASSEMBLY	2602202C91	1
